CAPSULE SUMMARY SHEET								
Survey No.	CAR-170 (PACS 3)	Construction Date: circa 1920						
Name: Banning Property I								
Location:	20820 Dover Bridge Road, Ta	nyard Vicinity, Caroline County

MARYLAND HISTORICAL TRUST
STATE HISTORIC SITES INVENTORY FORM
DESCRIPCE NAME: Panning Property I

RESOURCE NAME: Banning Property I SURVEY NO.: CAR-170 (PACS 3)

>RESS: 20820 Dover Bridge Road, Tanyard Vicinity, Caroline County

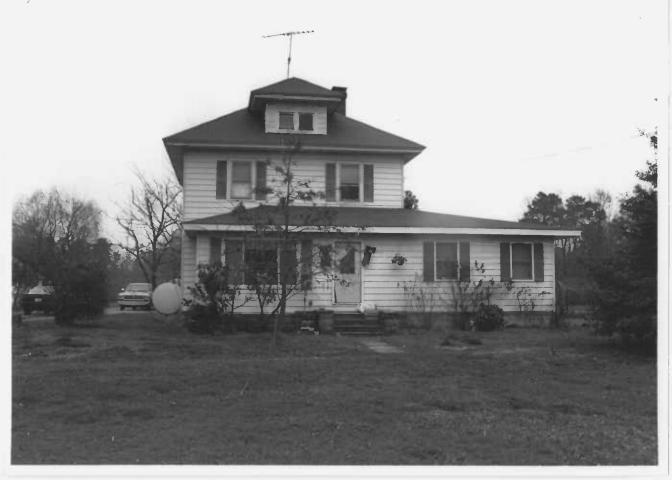
CAR-1110 BANAING PROPERTY ! CAROLINE COLATH, MD. COUTH EXEVATION 1 of 15

The south, or front elevation has an enclosed porch and a 1-story addition on the east side. The first story entrance is in the second bay of the enclosed porch. The fenestration pattern is symmetrical. The enclosed porch has a 3-light fixed-sash window in the first bay, and two 1/1 double-hung windows in the third and fourth bays. The second story has two 1/1 double is gwindows. There is a hipped-roof dormer centered on the roof, with one 2-light sliding window. There are louvered aluminum shutters affixed to all the windows except the dormer window. Typical elements of the style, including a pyramidal-hipped roof and hipped dormer are evident on this elevation. Alterations to the elevation include the enclosure of the porch and the addition built on the east side of the porch.

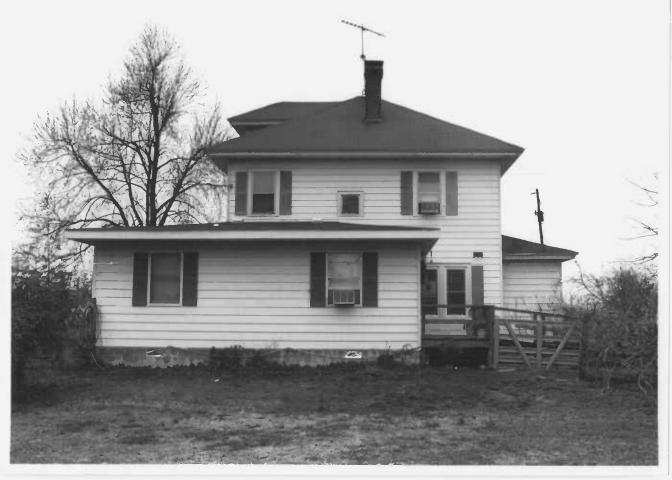
CARTIO BANNING PROPERTY ! CAROLINE COUNTY, MD EURAL TAMBE 1188 EAST ELEVATION 30-15

The east elevation has a 1-story hipped-roof addition and a wooden ramp leading up to that addition from the north. The fenestration pattern is regular, with two 1/1 double-hung windows in the addition and two paired 1/1 windows in the northern bay of the main block. The second story had two 1/1 double-hung windows and a small, square louvered vent. There are louvered aluminum shutters flanking all the windows. The chimney pierces the roof of this elevation.

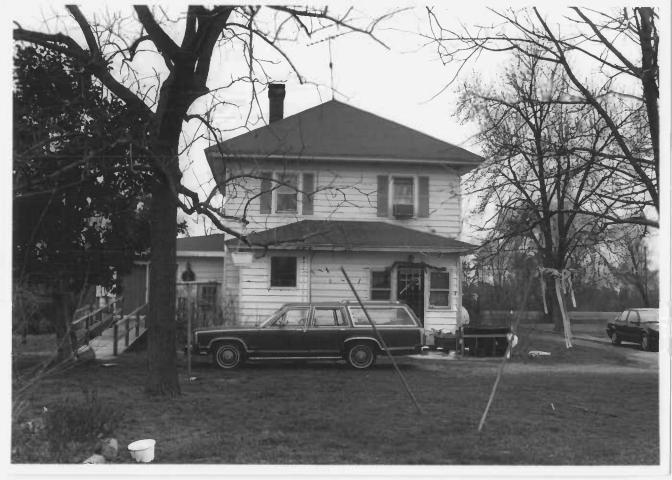
CAR-110 BANAING HEOFIETH ! CARCUME COUNTY, MD CUSAN TAYLOR 1197 MO SHPO NORTH ELEVATION 5 OF 15

The north, or rear elevation has an enclosed porch and a 1-story addition on the east side. There is an entrance in the second bay of the enclosed porch. The fenestration pattern is irregular, with two 1/1 double-hung windows flanking the door, one 1-light, fixed-sash window in the fourth bay of the enclosed porch, one 9-light door in the first bay of the addition and a set of sliding glass doors in the second bay of the addition. A railed wooden ramp leads to a small deck in front of the sliding glass doors. The second story has two 1/1 double-hung windows. There are louvered aluminum shutters attached to the second story windows.

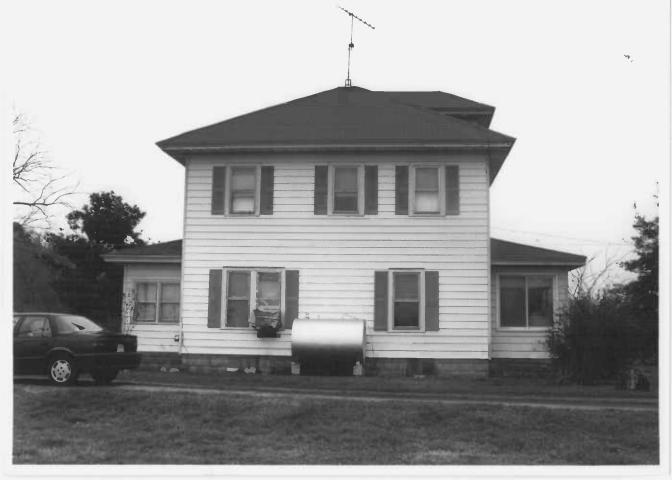
(CAR-170 (PACS 3) L BANNING PROPERTY I CAROLINE CO. MD U SUSAN TAYLOR LNUARY 938 MARYLAND SHPO HOUSE WEST ELEVATIONS 17 OF 15

The west elevation consists of the western elevation of the main block and the front and rear enclosed porches. The fenestration pattern is asymmetrical. The basement level has two 2-light fixed-sash windows. There is a pair of 1/1 double-hung windows in the west elevation of the enclosed rear porch. The enclosed front porch has one 2-light sliding window on the west elevation. The first story of the main block has two paired 1/1 double-hung windows in the first bay and a single 1/1 double-hung window in the second bay. The second story has three double-hung windows. There are louvered aluminum shutters affixed to the windows of the main block.

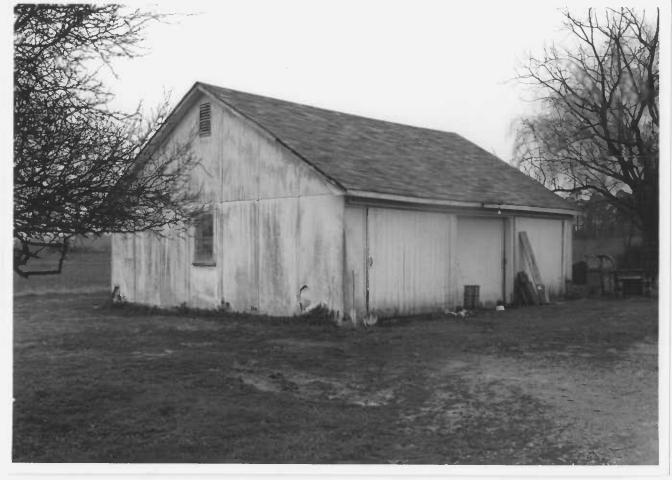
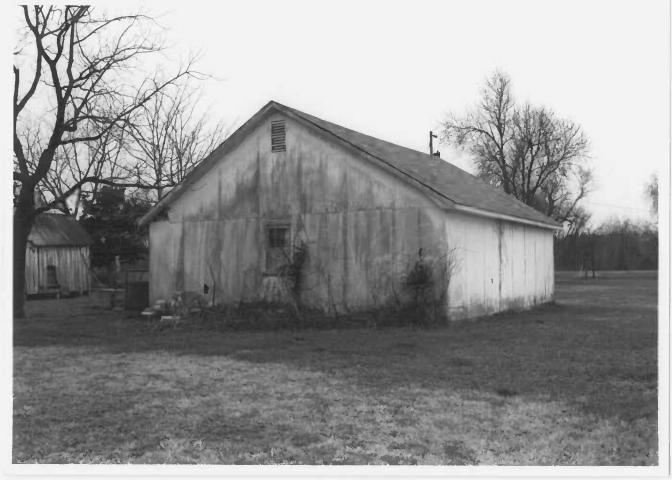
(CAR-170 (PACS 3) 2 BANNING FROPERTY I 3 CARDLARE CO. MD SUSAN TAYLOR JANUARY 1998 MARYLAND SHOO 7 BARN, SOUTH & EAST ELEVATIONS 4 9 OF 15

There are four outbuildings associated with this building. The first outbuilding is a 1-story barn, with an asphalt-shingle side-gable roof. Constructed circa 1920, it is of wood-frame construction covered in vertical-board siding. The foundation is a combination of concrete block and wood beams. There are three large sliding doors on the east elevation. The north and south gable ends both have one 6/6 double-hung window centered on the wall and a louvered vent in the gable end. The barn is located northwest of the house and west of the other outbuildings.

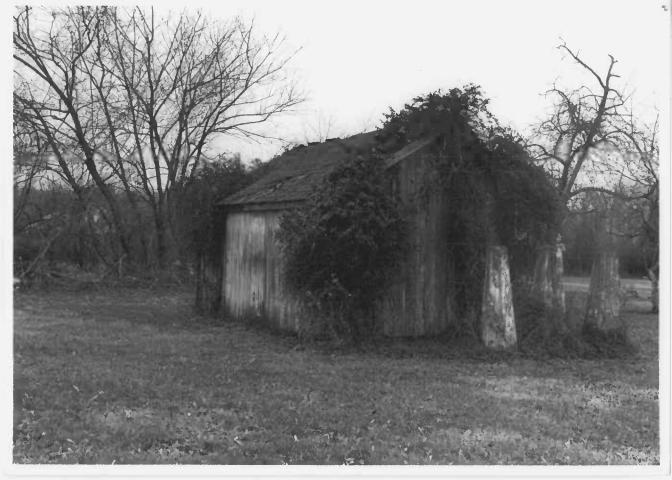
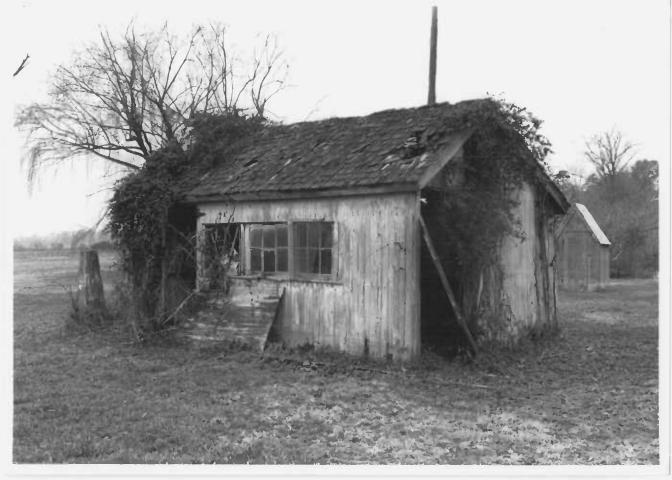
CAR-170 (PACS 3) BANNING PROPERTY I 3 CARDLINE CO, MD 4 SUSAN TAYLOR S JANUARY 1998 MARYLAND STOO THEN HOUSE, NORTH & WEST ELEVATIONS 8 11 OF 15

The third outbuilding is a hen house with a wood-shingled side-gable roof. Constructed circa 1920, it is of wood-frame construction with vertical board siding. There are a door and three 6-light windows on the south elevation and a door on the east elevation. The hen house has concrete foundation. The structure is located north of the corncrib and house, south of the pymohouse, and east of the barn.

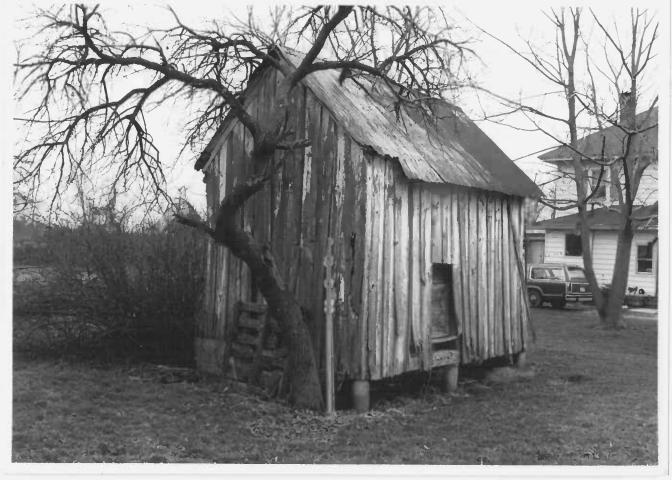
(CAR-170 (PAGS 3) BANNING PROPERTY 1. CARDENE CO, MD 4 SUSAN TAYLOR PAUREN 993 6 MARULAND 5400 7 GRANARY NORTH WEST ELEVATIONS 9 13 OF 15

The second outbuilding is a granary with a corrugated metal, front-gable roof. Constructed circa 1920, it is of wood-frame construction with vertical board siding. The granary is supported on piers. There is a doorway on the south elevation, and a grain door on the west elevation. It is located north of the house, east of the of the barn, and south of the hen house and pump house.

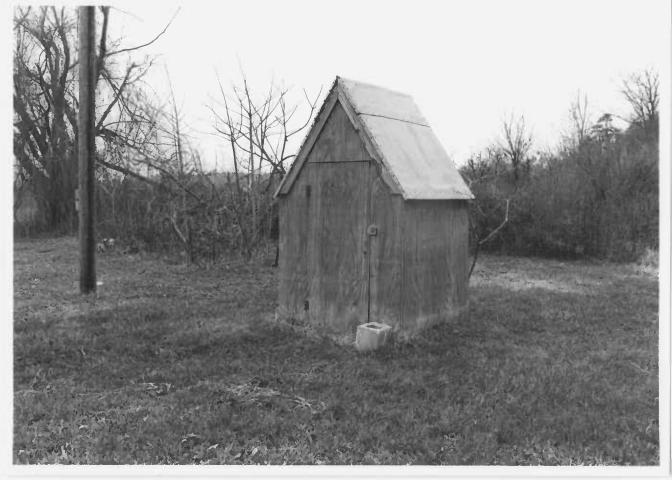
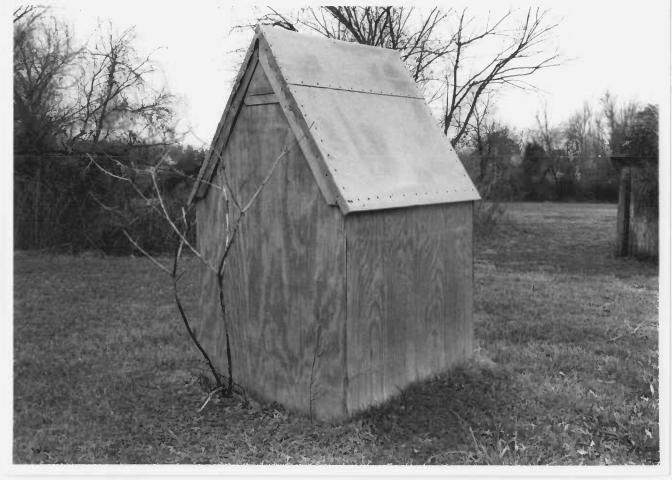
(CAR-170 (PACS 3) BANNING PROPERTI 3 CARBLINE GO, MD + SUSAN TAYLOR JAMUARY 1998 MARYLAND SHOO POMP HOUSE, SOUTH ! EAST ELEVATIONS 14 OF 15

The fourth outbuilding is a front-gable pumphouse. Constructed circa 1980, it is of wood-frame construction covered in plywood, and it has a door on the south elevation. It is located north of the house, corncrib, and hen house, and east of the barn.
